# **Effects of Initial Conditions in a DRSSTC**

**Steven Ward**

**6/26/09**

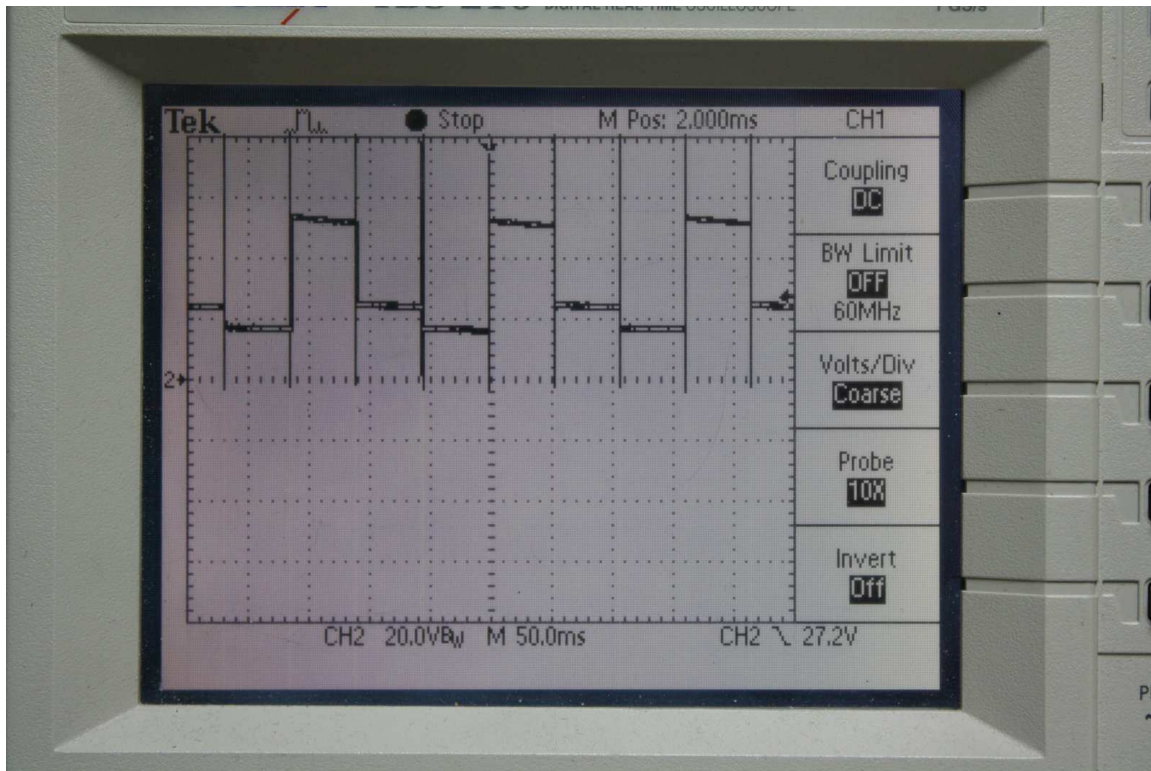
Trace showing the MMC residual voltage after each firing, note the time scale.

Why is this left-over charge a problem? In my system, oscillation is based purely on feedback from the primary current, without this feedback, the system cannot oscillate. The capacitor charge can either be a benefit, or a hindrance depending on the polarity of the charge with respect to the start-up voltage applied from the bridge. Lets say the capacitor is left with a  $+V_{bus}$  charge, and upon receiving start command from the controller, the bridge switches in such a manner as to apply  $+V_{bus}$  to the tank circuit. Because the capacitor is already charged to  $+V_{bus}$ , there will be no current flow from the bridge to the capacitor, which means there will be no primary current feedback to sustain system oscillation. This then causes the gate drive system to fall on its face as the GDT saturates from exceeding its Volt-Second product. Interestingly, as the GDT saturates, the leakage inductance “rings” such that some voltage is applied to the opposing bridge switches (which were initially given an OFF command) causing the system to spring to life! This is a sloppy, marginally stable situation that needs to be fixed.

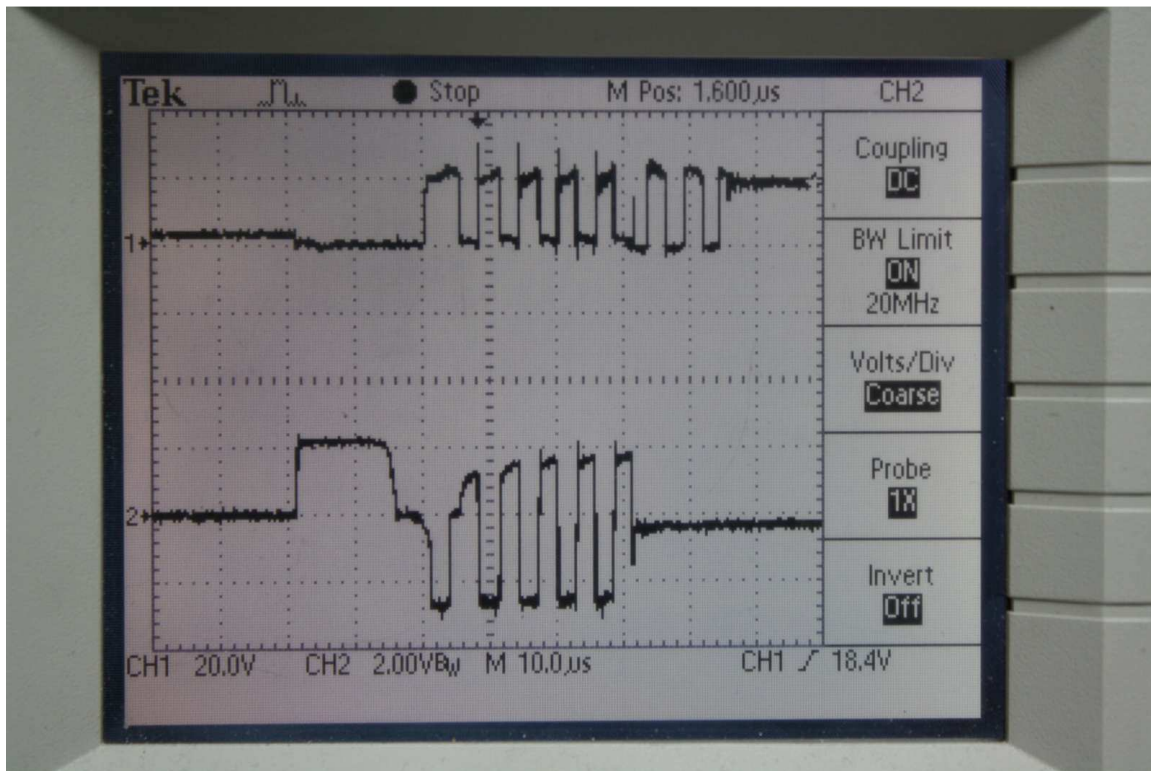
Half-bridge output and GDT output voltage during a false start

Trace 1 shows the half-bridge output voltage, and since the tank circuit is returned back to the bus negative rail (which is also the reference for my scope probe) you are actually seeing the tank capacitor voltage while the system is not oscillating. So at the start the tank cap is nearly discharged (this was done intentionally with a bleeder resistor). Trace 2 shows the  $V_{ge}$  for the low-side IGBT. Upon start up, the driver switches the low side IGBT ON, which of course only serves to try and further discharge a mostly discharged tank capacitor, in which case the current flow in the primary circuit is so small that it does not yield enough signal strength for oscillation. As the gate drive output collapses, it somehow manages to turn on the high-side IGBT, which charges the output to  $V_{bus}$ , and causes current to flow into the primary circuit, giving feedback and causing solidly sustainable oscillation. Note a problem here... the saturated GDT has a volt-second imbalance, which is seen here by a slowly rising positive gate drive waveform (it takes about 3 cycles for it to return to its normal bias point). The negative portion of the gate drive waveform is clipped hard with TVS diodes; otherwise it would show an excessively negative waveform here. The TVS clamping diodes help reset the core to its natural V-s balance, without them the IGBT gates could see as much as 48V peak, or the total peak-to-peak applied voltage, but in one direction! This is good reason to always use some form of gate voltage clamp protection.

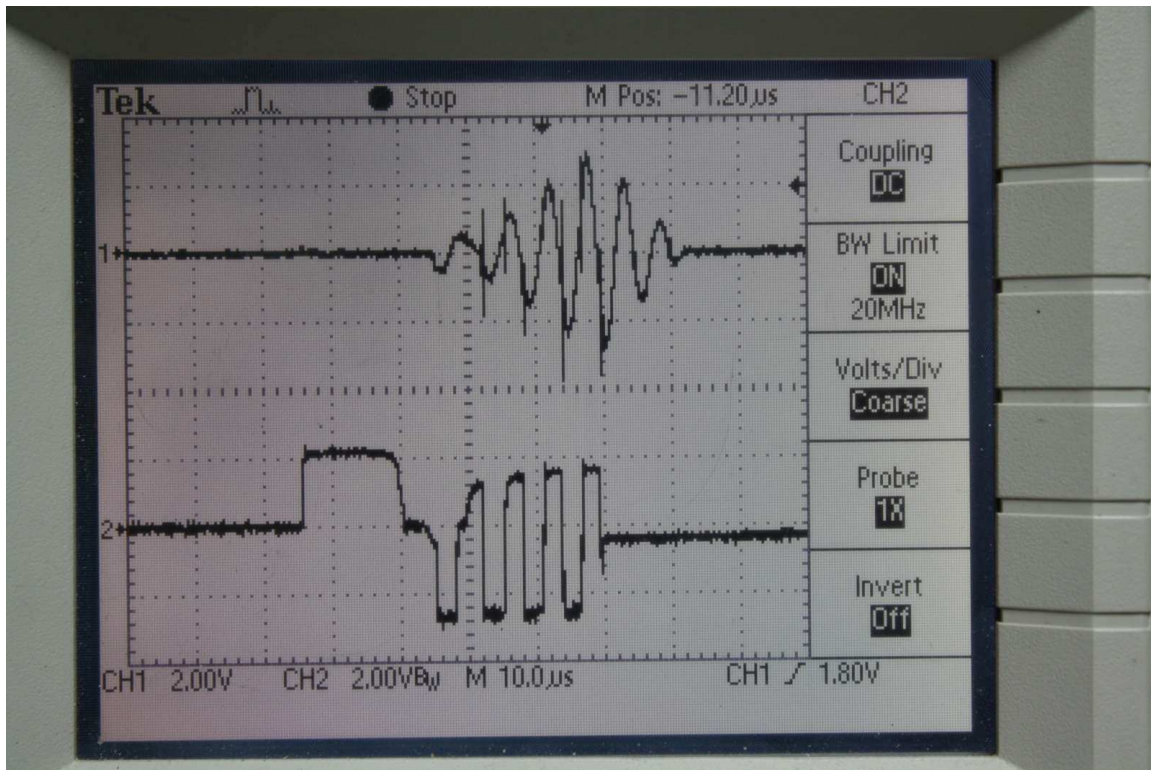
Primary current vs. Vgs under false-start condition

In this waveform, trace 1 is the primary current, which as seen is basically zero during the false start pulse. This false start condition is somewhat saved by the fact that the primary current is very low at start up, and the system can put up with poor gate drive waveforms and such because its not switching appreciable currents yet. But, this condition should be avoided when possible!

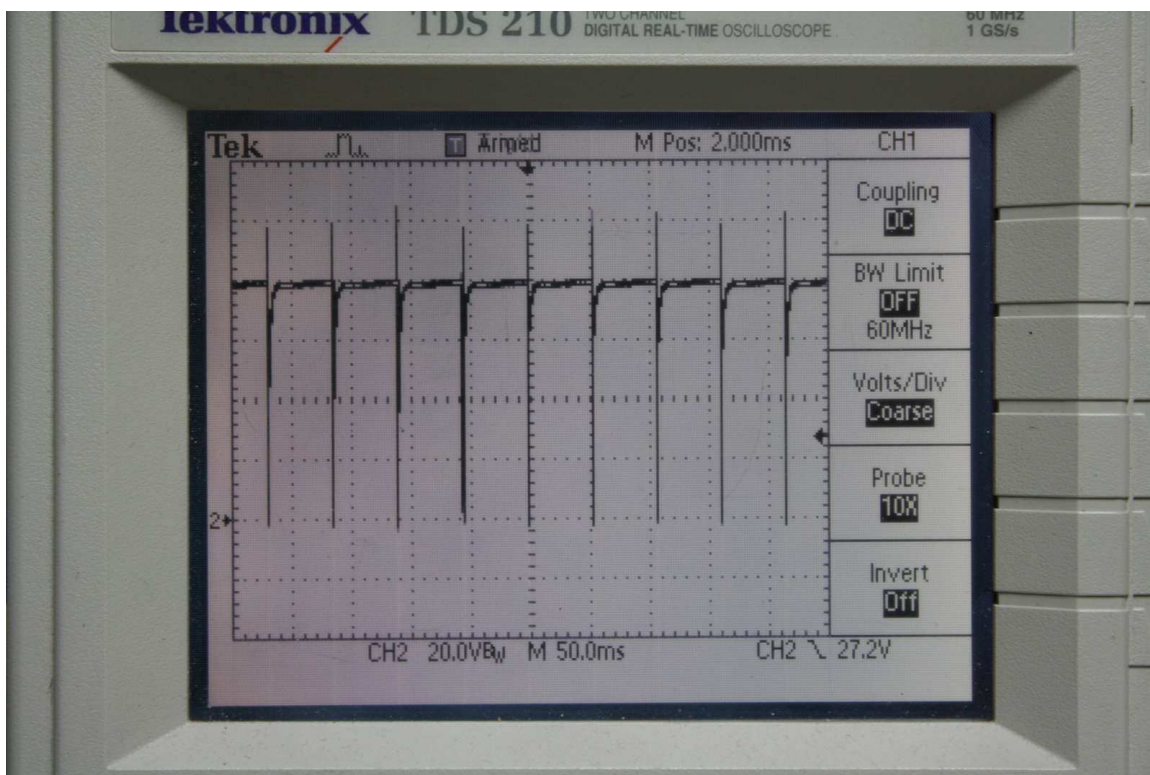
Capacitor residual voltage is now “fixed” with the addition of pull-up resistor, again note the time scale showing several firing events.  $V_{bus} = 80VDC$ .

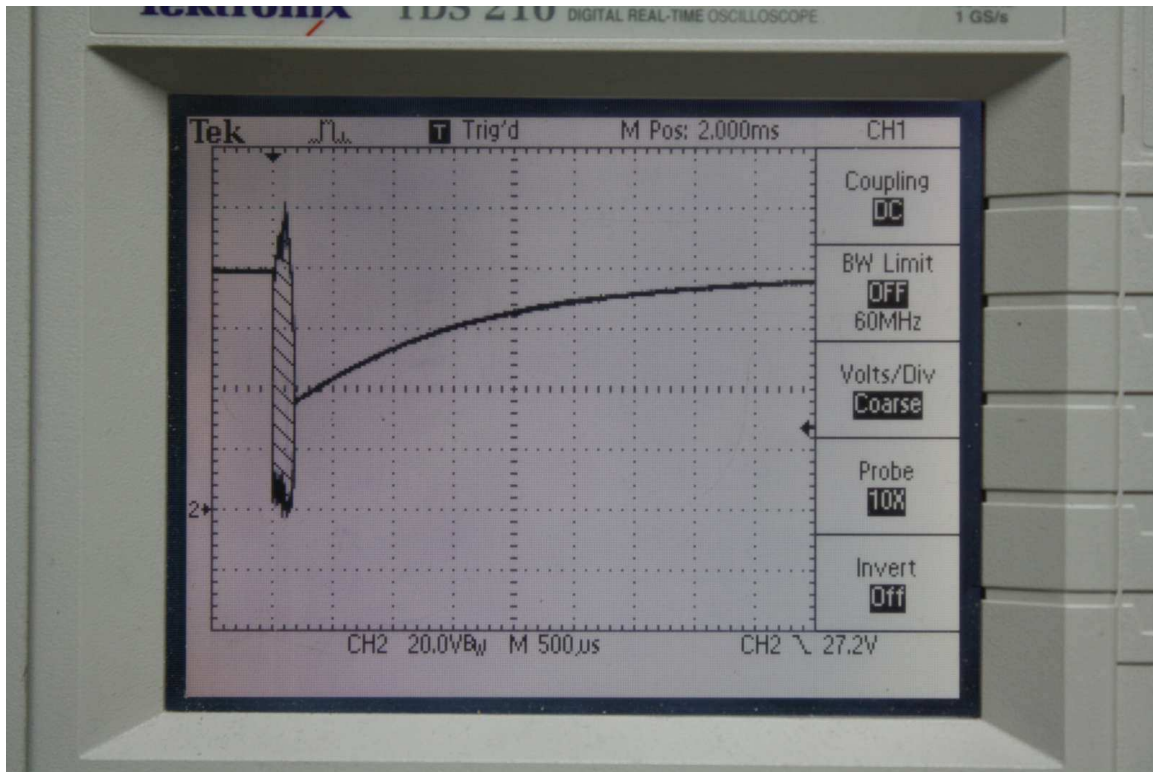
One bang with resistive recharge of the capacitor afterward

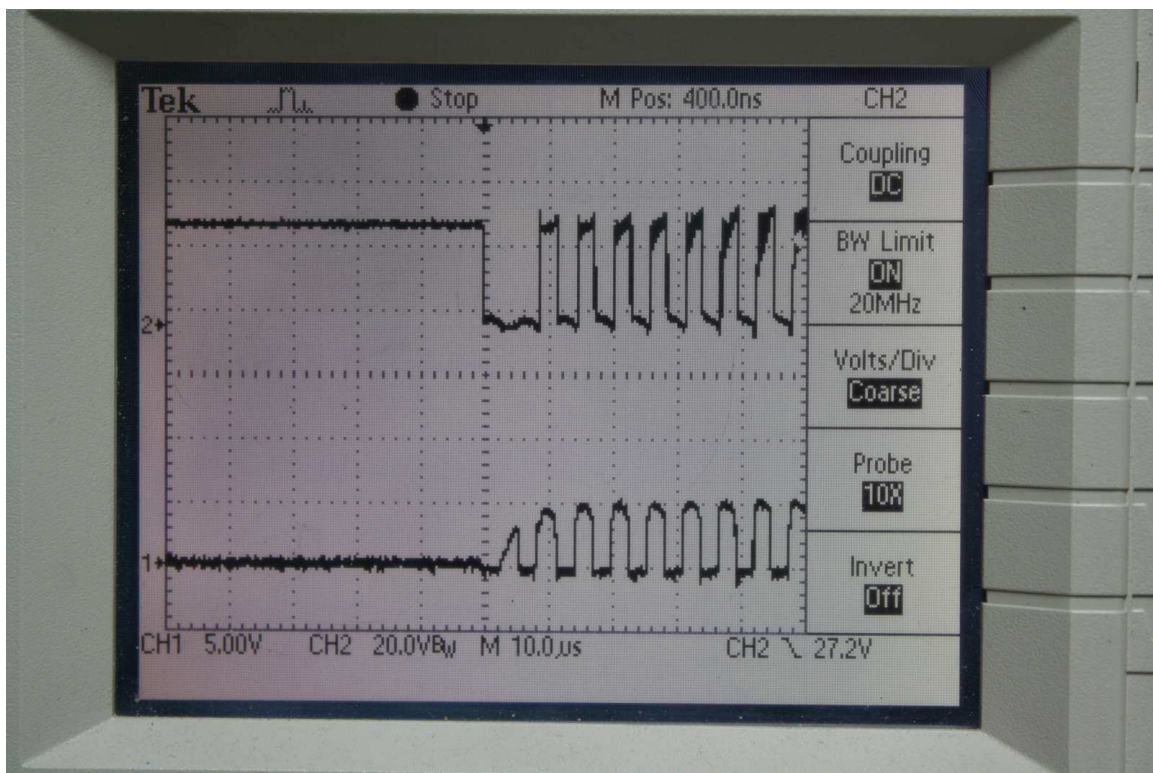
Top trace is output voltage from half-bridge, bottom trace is feedback voltage into pin 1 of 7414, the signal just isn't strong enough at the start so 1 cycle is missed. Note  $V_{bus}$  is only about 25VDC.

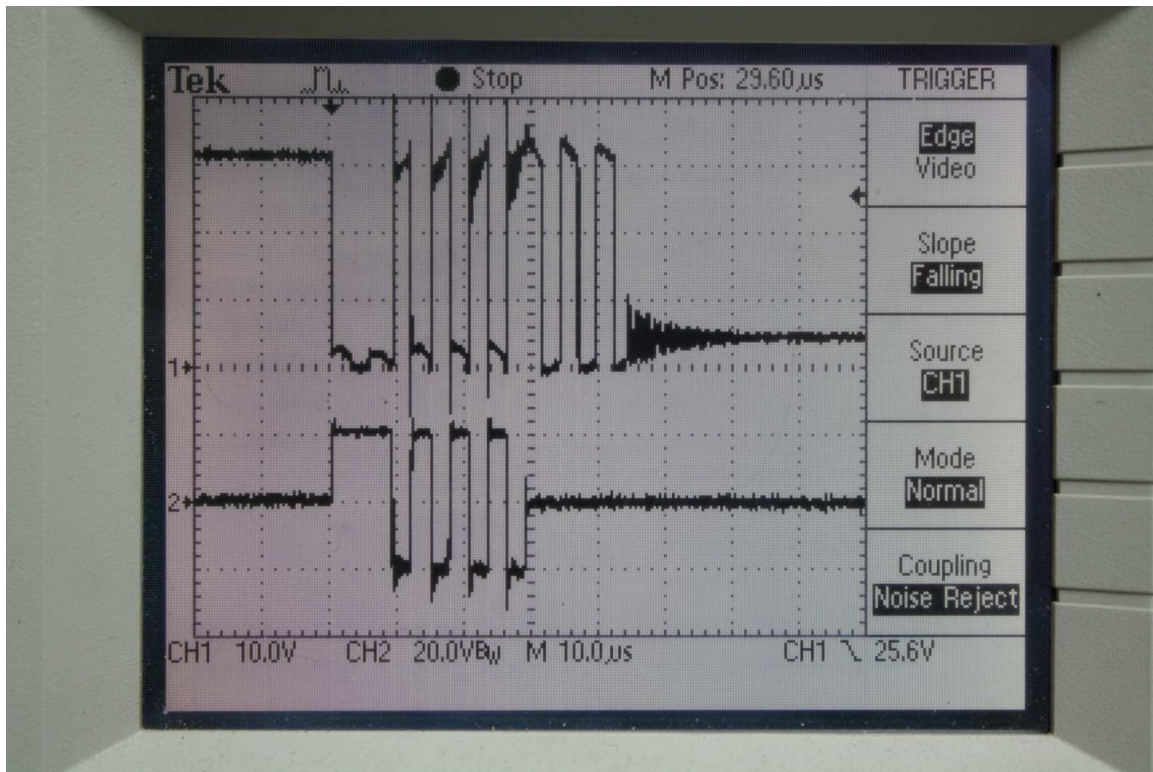
Half bridge output Vs. Gate drive signal. Note the extended first half-cycle, yet there is no significant DC offset on the gate drive waveforms as the GDT supports this OK.  $V_{bus} = 30V$ .

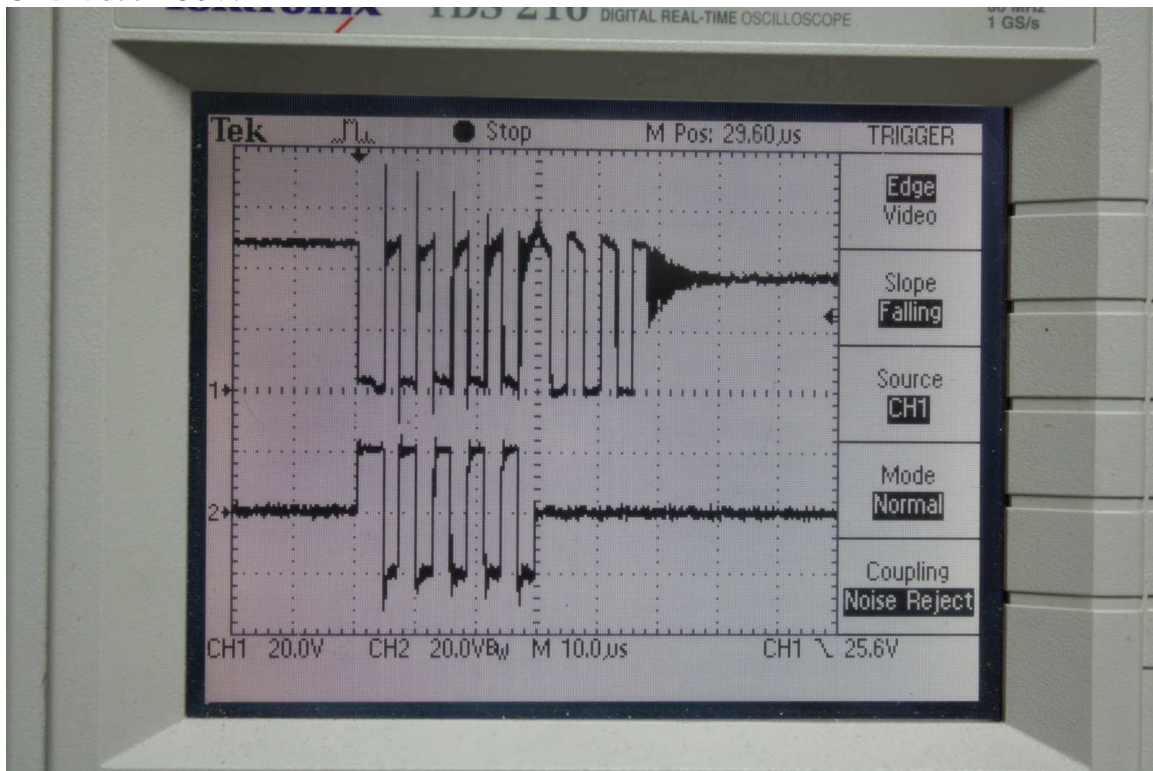
Things start looking better with  $V_{bus}$  nearly 50VDC.

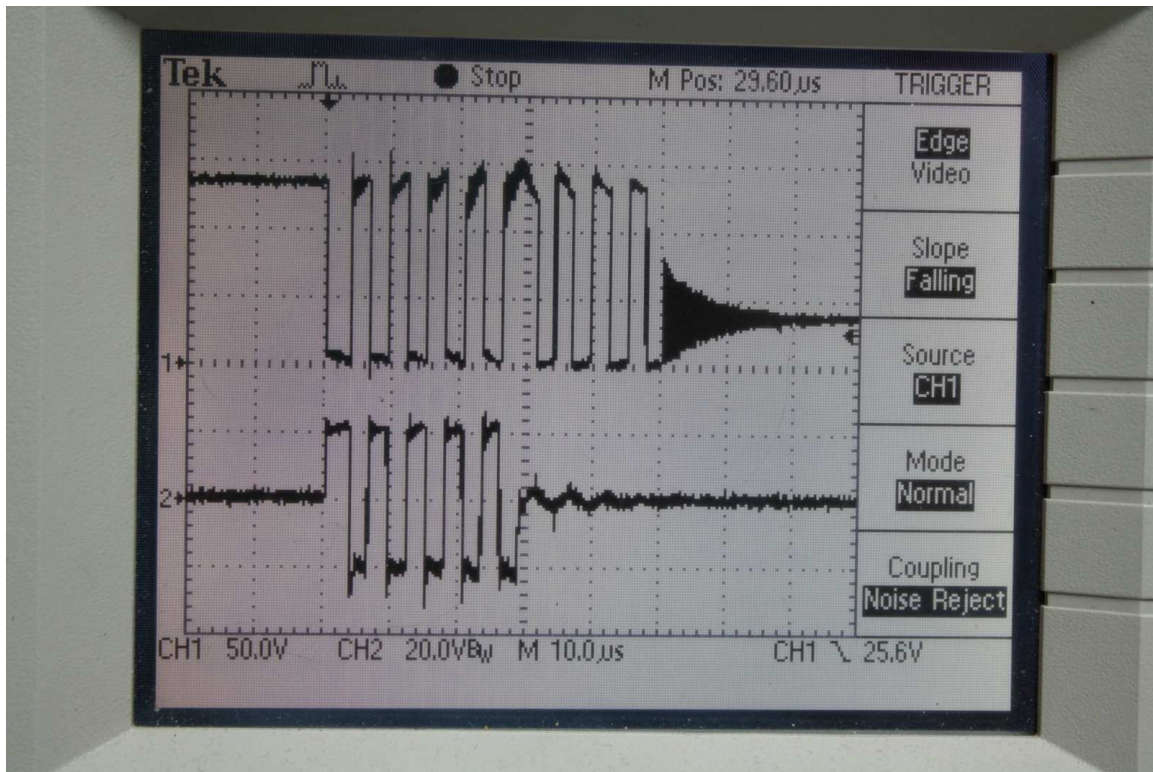
These waveforms look completely acceptable at 140VDC.
